**NEW YORK GATEWAY
CONNECTIONS IMPROVEMENT PROJECT
TO THE US PEACE BRIDGE PLAZA**

**Final Design Report/Environmental
Impact Statement**

**APPENDIX I – VISUAL IMPACT
ASSESSMENT**

**PIN 5760.80
City of Buffalo
Erie County, New York**

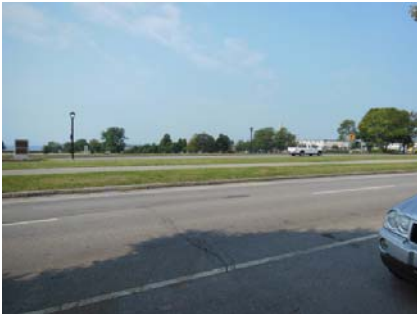
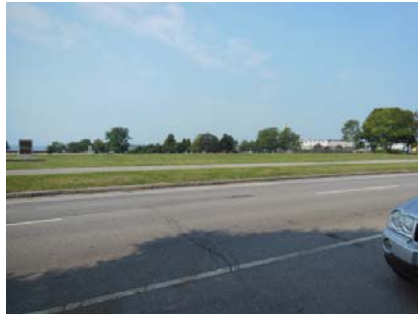
Visual Impact Assessment Worksheet						
Project:	New York Gateway Connections Improvement Project to the US Peace Bridge Plaza				Alternative:	Proposed Action
Location:	Busti Avenue Looking West				Key View No.	5
Photos	Existing		Proposed

Viewer Group:	Local Residents		Landscape Unit:	Urban Residential	
	Existing		Proposed		Change	
VIVIDNESS	The view is dominated by Busti Avenue and the park's open lawn which contain no unique or memorable elements. The striking view of Lake Erie is obscured by the vegetation and plaza subtracting from the water's relation to the landscape. The vividness rating is low.		The view is dominated by Busti Avenue and the park's open lawn which contain no unique or memorable elements. The striking view of Lake Erie is obscured by the vegetation and plaza subtracting from the water's relation to the landscape. The vividness rating is low.		Vividness rating would not change.

VIVIDNESS RATING:	2.0	VIVIDNESS RATING:	2.0	VIVIDNESS RATING:	0
INTACTNESS	There is a strong visual order with the pavement in the foreground, open lawn in the middleground and the landscaping in the background. The minor trees and plaza access does little to subtract from this order. Few man-made features dot the landscape providing a more naturalized viewshed. The intactness rating is moderately high.		There is a strong visual order with the pavement in the foreground, open lawn in the middleground and the landscaping in the background. The minor trees do little to subtract from this order, while the removal of man-made features, including Baird Drive, strengthens the open lawn area. Few man-made features dot the landscape providing a more naturalized viewshed. The intactness rating is high.		Intactness rating would slightly increase.	
	INTACTNESS RATING:	5.0	INTACTNESS RATING:	5.5	INTACTNESS RATING:	+0.5

Visual Quality (V+I+U)/3	3.5	Visual Quality (V+I+U)/3	3.8	Visual Quality (V+I+U)/3	0.3

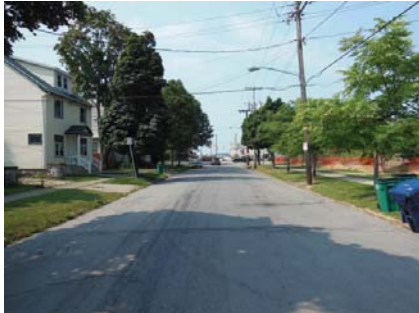
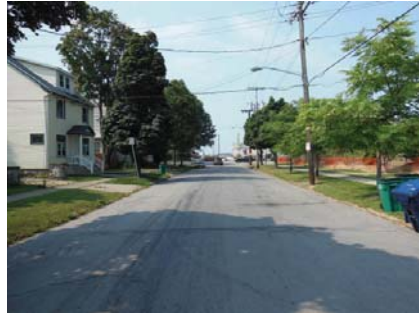
Visual Impact Assessment Worksheet							
Project:	New York Gateway Connections Improvement Project to the US Peace Bridge Plaza				Alternative:	Proposed Action	
Location:	Vermont Street Looking Southwest				Key View No.	6	
Photos	Existing			Proposed

Viewer Group:	Local Residents / Business Employees		Landscape Unit:	Urban Residential		
	Existing		Proposed		Change		
VIVIDNESS	The lining of street trees manipulate the view focusing on the plaza's gated entrance and facility which is not unique or memorable. Man-made elements are scattered throughout the view providing too many contrasting elements. The vividness rating is low.		The lining of street trees manipulate the view focusing on the Plaza's gated entrance and facility which is not unique or memorable. Man-made elements are scattered throughout the view providing too many contrasting elements. The vividness rating is low.		Vividness rating would not change.

VIVIDNESS RATING:	1.5	VIVIDNESS RATING:	1.5	VIVIDNESS RATING:	0	
INTACTNESS	The two story residences with the street trees present a fairly intact view of an urban residential street. The varying architectural styles, materials, colors and textures is typical for this type of neighborhood. Utility poles and overhead wires encroach on the residential street image. The intactness rating is low.		The two story residences with the street trees present a fairly intact view of an urban residential street. The varying architectural styles, materials, colors and textures is typical for this type of neighborhood. Utility poles and overhead wires encroach on the residential street image. The intactness rating is low.		Intactness rating would not change.		
	INTACTNESS RATING:	2.5	INTACTNESS RATING:	2.5	INTACTNESS RATING:	0	
UNITY	Street details, including pavement, sidewalks, planting area and lawn, are well defined and maintained. The utility poles and overhead wires degrade the overall harmony of the view. The unity rating is low.		Street details, including pavement, sidewalks, planting area and lawn, are well defined and maintained. The utility poles and overhead wires degrade the overall harmony of the view. The unity rating is low.		Unity rating would not change.

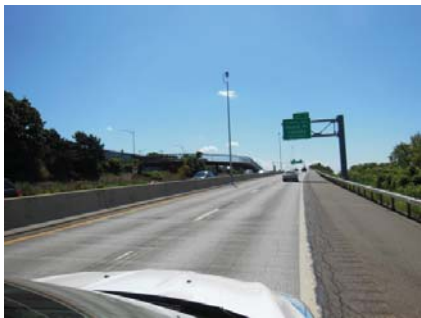
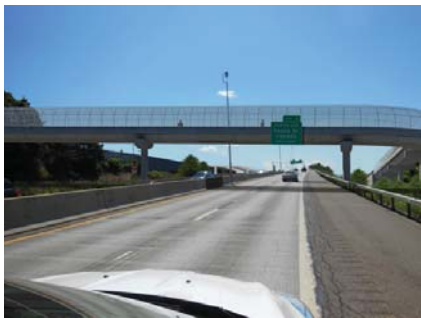
Visual Impact Assessment Worksheet							
Project:	New York Gateway Connections Improvement Project to the US Peace Bridge Plaza				Alternative:	Proposed Action	
Location:	Southbound I-190 Looking South				Key View No.	8	
Photos	Existing			Proposed

Viewer Group:	Business Employees / Travelers / Commuters		Landscape Unit:	Transportation Corridors		
	Existing		Proposed		Change		
VIVIDNESS	<p>The highway pavement with vegetation to the east and west is not unusual making this view unmemorable. Man-made elements are scattered throughout the view providing too many contrasting elements. The vividness rating is low.</p>		<p>The view of the pedestrian bridge crossing the viewshed provides a unique element within a typical highway viewshed. Man-made elements are scattered throughout the view providing too many contrasting elements. The vividness rating is moderate/average.</p>		<p>Vividness rating would increase.</p>

VIVIDNESS RATING:	2.5	VIVIDNESS RATING:	3.5	VIVIDNESS RATING:	+1.0	
INTACTNESS	<p>The trees and shrubs along the east partially screen views of Ramp S and the pedestrian bridge. However, the highway disrupts the connection between the natural setting to the west and the one to the east, thus creating conflicting landscape characters. The intactness rating is low.</p>		<p>The pedestrian bridge and highway disrupt the connection between the natural settings on the east and west, with the bridge almost eliminating the vegetation on the west. The intactness rating is low.</p>		<p>Intactness rating would decrease.</p>		
	INTACTNESS RATING:	2.5	INTACTNESS RATING:	1.5	INTACTNESS RATING:	-1.0	
UNITY	<p>Minimal vegetation with the highway in the middle degrades the natural setting creating little harmony between the man-made and natural elements. The vegetation and highway's contrasting colors and textures provide little integration of the man-made elements with its surrounding landscape. The unity rating is moderately low.</p>		<p>The various highway features and minimal vegetation provides little harmony between the man-made features and the natural elements. However, the similar color and simple textures of the pedestrian bridge provides some unity within the man-made features. The unity rating is moderately low.</p>		<p>Unity rating would increase.</p>

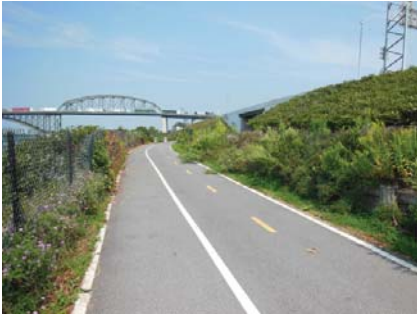
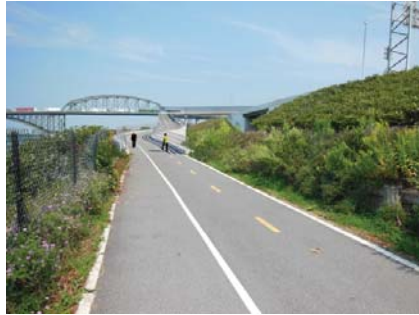
Visual Impact Assessment Worksheet						
Project:	New York Gateway Connections Improvement Project to the US Peace Bridge Plaza				Alternative:	Proposed Action
Location:	Shoreline Trail Looking North			Key View No.	9	
Photos	Existing		Proposed

Viewer Group:	Recreational Users		Landscape Unit:	River / Waterfront	
	Existing		Proposed		Change	
VIVIDNESS	The view along the Shoreline Trail presents an attractive view of the Peace Bridge in the distance. In addition, the overgrown vegetation in the foreground and middleground provides varying texture and color making the view memorable. The vividness rating is high.		The view along the Shoreline Trail presents an attractive view of the Peace Bridge in the distance. The introduction of the pedestrian bridge and ramp reduces the overall impact from the varying texture and color from the overgrown vegetation in the foreground and middleground. The vividness rating is high.		Vividness rating slightly decrease.

VIVIDNESS RATING:	6.5	VIVIDNESS RATING:	6.0	VIVIDNESS RATING:	-0.5
INTACTNESS	The Peace Bridge structure encroaches on the mainly natural landscape within the viewshed drawing ones focus away from the landscape and onto the man-made structure. The chain-link fence within the vegetation competes with the natural form, colors and texture of the landscape. The intactness rating is low.		The Peace Bridge structure and the pedestrian bridge and ramp encroaches on the mainly natural landscape within the viewshed drawing ones focus away from the landscape and onto the man-made structures. The chain-link fence within the vegetation competes with the natural form, colors and texture of the landscape. The intactness rating is low.		Intactness rating decrease.	
	INTACTNESS RATING:	2.5	INTACTNESS RATING:	1.5	INTACTNESS RATING:	-1.0
UNITY	Except for the bridge in the background, the natural vegetation blends with the man-made structures of the I-190 underpass and chain-link fence. The curve at the end of the Shoreline Trail ties the man-made structure with the surrounding landscape creating a unity between the natural and man-made elements. The unity rating is moderately high.		The pedestrian bridge and ramp plus the Peace Bridge in the background, reduces the unity between the natural vegetation and man-made structures. The Shoreline Trail's ramp disrupts the natural vegetation along the shoreline, reducing the overall unity of the natural landscape. The unity rating is moderately low.		Unity rating would decrease.

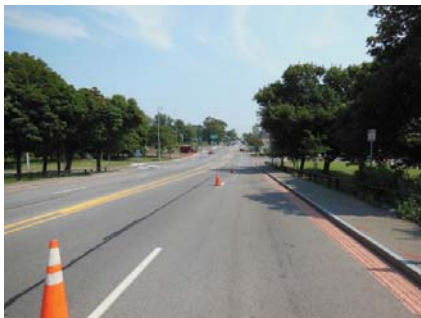
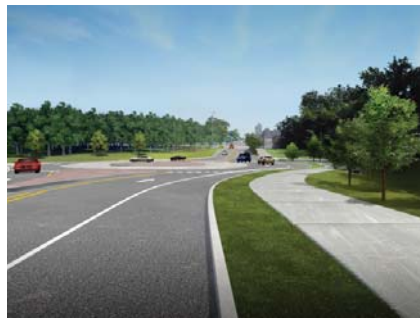
Visual Impact Assessment Worksheet						
Project:	New York Gateway Connections Improvement Project to the US Peace Bridge Plaza				Alternative:	Proposed Action
Location:	Porter Avenue Looking Northeast (Roundabout Option)			Key View No.	10a	
Photos	Existing			Proposed

Viewer Group:	Local Residents / Business Employees / Travelers / Commuters / Recreational Users		Landscape Unit:	Transportation Corridors	
	Existing		Proposed		Change	
VIVIDNESS	<p>The foreground and middleground views are dominated by Porter Avenue and roadside elements, including street trees, which are typical and unmemorable. The commercial buildings in the background are partially obscured by the vegetation. The vividness rating is low.</p>		<p>The foreground and middleground views are dominated by the roundabout, which is a unique element within the viewshed. The lack of a focal element within the roundabout provides a more typical streetscape and is unmemorable. The commercial buildings in the background are partially obscured by the vegetation. The vividness rating is moderate/average.</p>		<p>Vividness rating would increase.</p>

VIVIDNESS RATING:	2.5	VIVIDNESS RATING:	3.5	VIVIDNESS RATING:	+1.0
INTACTNESS	<p>Porter Avenue and its street trees provides visual continuity from foreground to the background. Porter Avenue's roadside elements, such as the brick edging, sidewalks, street trees and maintained lawn areas provide visual order. The intactness rating is moderate/average.</p>		<p>The roundabout disrupts Porter Avenue and its street trees reducing the visual continuity from foreground to background. However, the roadside elements, such as sidewalks, street trees and maintained lawn areas provide visual order. The intactness rating is moderate/average.</p>		<p>Intactness rating would slightly decrease.</p>	
	INTACTNESS RATING:	4.0	INTACTNESS RATING:	3.5	INTACTNESS RATING:	-0.5
UNITY	<p>The colors, textures and patterns of the roadside elements unify the man-made elements. The addition of the natural landscape creates a coherent visual pattern. The unity rating is moderately high.</p>		<p>The colors, textures and patterns of the roadside elements unify the man-made elements. The addition of the natural landscape creates a coherent visual pattern. The unity rating is moderately high.</p>		<p>Unity rating would not change.</p>

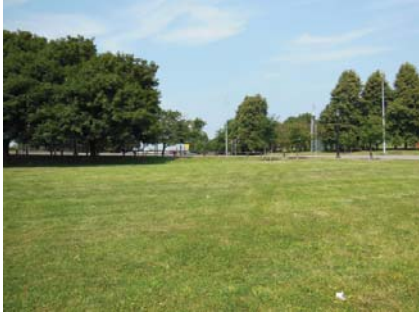
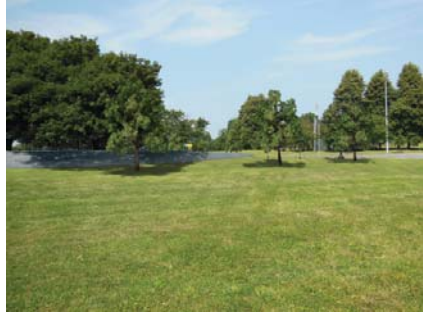
Visual Impact Assessment Worksheet							
Project:	New York Gateway Connections Improvement Project to the US Peace Bridge Plaza				Alternative:	Proposed Action	
Location:	D'Youville College Athletic Fields Looking North				Key View No.	11	
Photos	Existing			Proposed

Viewer Group:	Local Residents / Recreational Users		Landscape Unit:	Transportation Corridors		
	Existing		Proposed		Change		
VIVIDNESS	The open lawn in the foreground dominates the view and does not contain any unique or memorable elements. Porter Avenue in the middleground, with its utility and streetscape elements are typical and unmemorable. The vividness rating is low.		The open lawn in the foreground dominates the view and does not contain any unique or memorable elements. The Porter Avenue roundabout in the middleground, with its utility and streetscape elements, are typical and unmemorable. The vividness rating is low.		Vividness rating would not change.

VIVIDNESS RATING:	2.5	VIVIDNESS RATING:	2.5	VIVIDNESS RATING:	0	
INTACTNESS	Except for Ramp P in the background, the wooded middleground and background is mainly intact. In addition, Porter Avenue does little to disrupt the visual relationship between the open lawn and wooded background. The utility and streetscape vertical elements partially disrupts the natural setting of the viewshed. The intactness rating is moderately high.		Except for roundabout's retaining wall in the middleground, the vegetation in the middleground and background is mainly intact. In addition, the roundabout does little to disrupt the visual relationship between the open lawn and wooded background. The utility and streetscape vertical elements partially disrupts the natural setting of the viewshed. The intactness rating is moderate/average.		Intactness rating would slightly decrease.		
	INTACTNESS RATING:	4.5	INTACTNESS RATING:	4.0	INTACTNESS RATING:	-0.5
